HEALTH & SAFETY ALERT

Defective Double Couplers

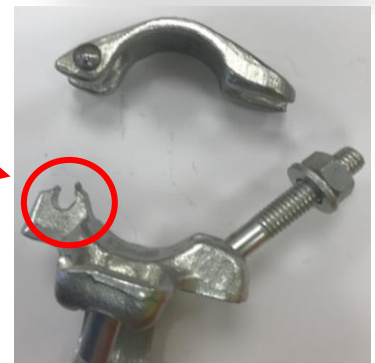
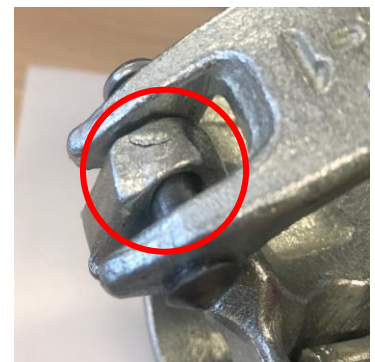
When erecting a handrail using tube and fitting, a drop forged double coupler failed when tightened. The coupler was immediately replaced, quarantined and reported by the vigilant member of our scaffold team. On initial inspection the coupler had sheared at the gate hinge pin lug.

- Incorrectly positioned lug holes
- Incorrectly tapped nut threads
- Incorrectly dyed bolts threads
- Missing and bent washers

The couplers were supplied by **Altrad Beaver84** and manufactured in China. Markings on the couplers seem to be correct stating **EN74-1 Class BL**. An investigation has been instigated by both KBJV and the Supplier.

- Quarantine all tube and clip scaffold pending visual inspection.
- Upon visual inspection remove and replace all double couplers with batch number **BM0218G**
- Re-inspect the scaffold and confirm with the scaffold Foreman.
